PRELIMINARY ASSESSMENT

POLLOCK COLLINS OIL

ANNISTON, ALABAMA; CALHOUN, COUNTY

Prepared By
Keevin M. Smith
Alabama Department of Environmental Management
Land Division-Hazardous Waste Branch
Site Assessment Unit

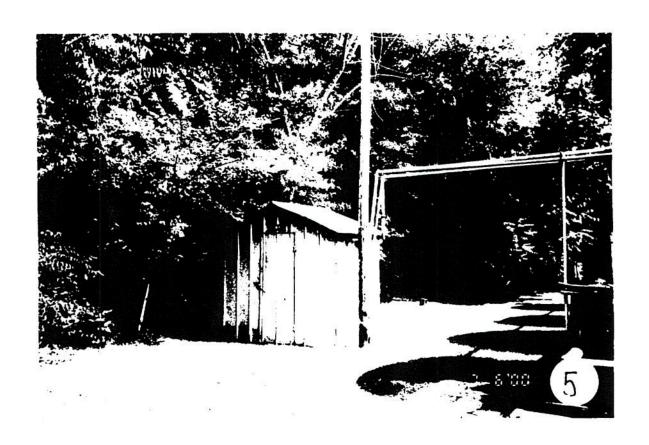
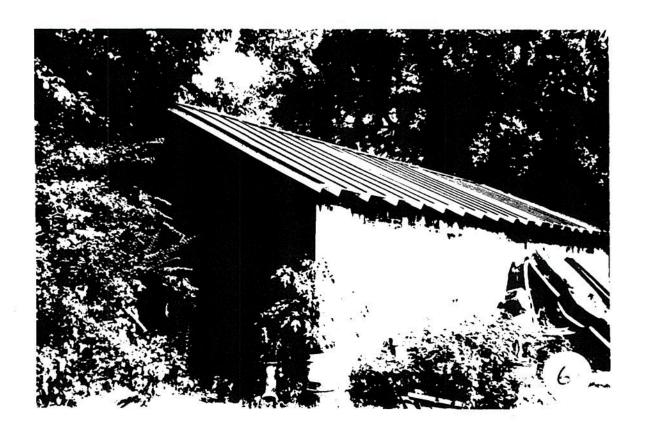
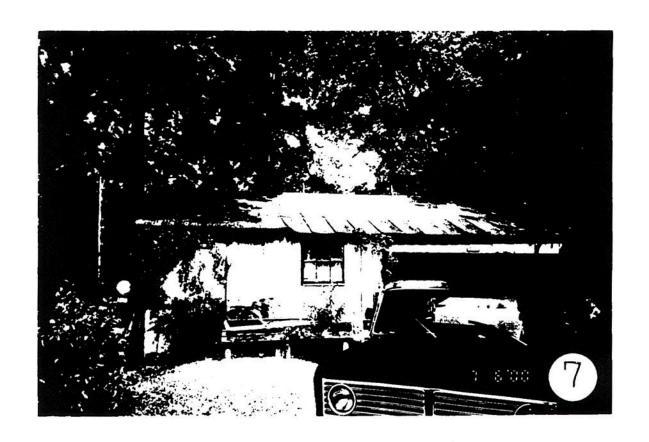
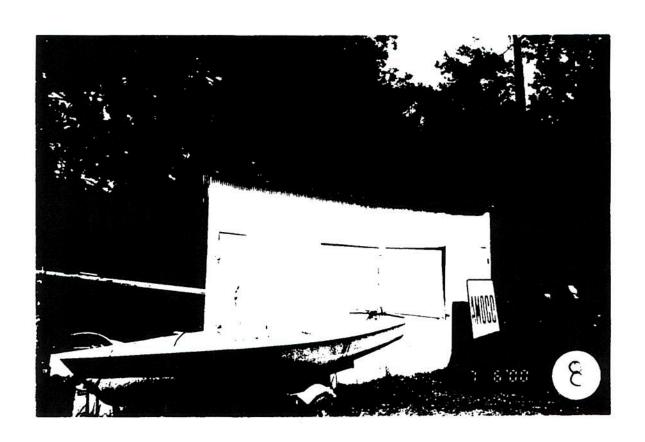
## **PHOTOGRAPHS**

- 1. The office and storage complex of Pollock Collins Oil; the east side of the site
- 2. Garage
- 3. Old drums, woody vegetation and general debris
- 4. Old truck and auto batteries, old drums
- 5. Pump House
- 6. Storage building littered with old sign and old drums
- 7. Storage building
- 8. Storage building
- 9. Storage building; littered with drums and old gas pumps
- 10. Old gas pumps
- 11. Stilted tanks that are diked
- 12. Pump with area of stained soil
- 13. Pump with area of stained soil
